Extreme tests at the North Sea

Exposing devices to extreme temperatures, saltwater, fouling, permanent vibrations, explosive atmospheres: tests in real-life conditions can be very telling. This is why steute opted to conduct a 1-year corrosion test at and in the North Sea for several of its switchgear series.

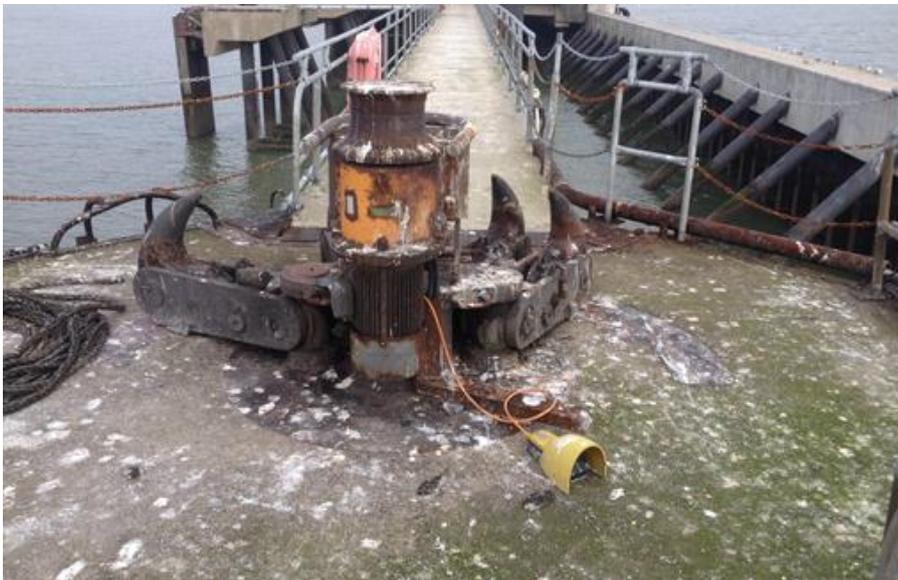
This foot switch for actuating a winch on a mooring hook is continually exposed to saltwater, fouling and seagull droppings – and yet functions perfectly.

The sort of applications the steute Extreme developers have in mind can be illustrated using three implemented examples. One Extreme foot switch is used in a coal terminal at a German sea port to actuate the winches on mooring hooks which secure the freight ships. In addition to splash water, these switches are application is an Extreme emergency pull-wire exposed to algae fouling and bird droppings. A second, even more corrosive
